# Detection of plastic pipes in a concrete floor

## Description of problem

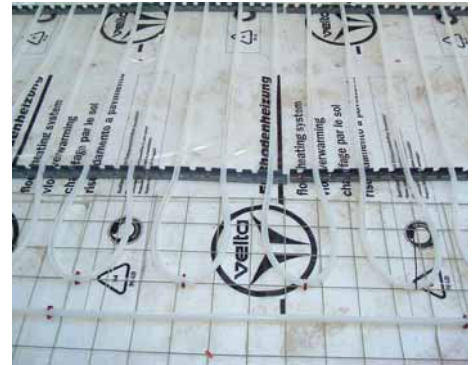
However, after the concrete were cast, pipes were seen on top of the concrete in a certain part of the floor. This led to the need of inspection of the status of the rest of the floor, as a certain amount of concrete (at least 100 mm) was needed to ensure an efficient and even heating distribution. Further on, interior walls are to be constructed on the floor, and these are nailed directly on the floor, so again there is a need for sufficient amount of concrete above the plastic pipes, to avoid puncture and leakage.

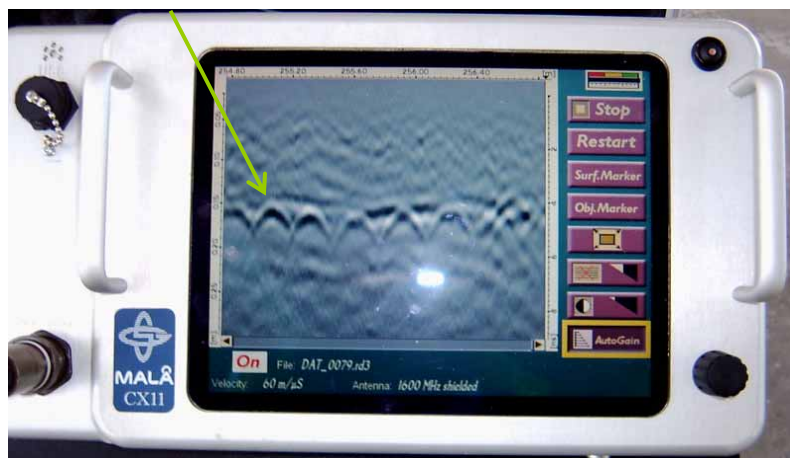
The CX together with the 1.6 GHz antenna gave good results (see picture below), the plastic pipes showed well (as clear hyperbolas, one marked with an arrow) on the radargram and the resolution was extremely good.

It was found that the majority of the pipe work system was buried at a depth exceeding 110 mm; only minor areas were found to rise to 100 mm. These areas were not of concern as they were relatively small and infrequent and did not coincide with the construction of the partitioned interior walls. However, two areas were found to have pipe work at less than 100 mm depth and in one case a reading as low as of 30 mm was found. These areas were clearly marked directly on the concrete surface.

This investigation gave immediate results, and it was possible to identify the areas directly onsite during the operation where the plastic pipe work was located too shallow. This was sufficient information for the constructor to avoid certain areas for further construction work, and to know where the pipe work has to be improved. The investigation area of 40 m x 25 m (densely profiled) was easily covered within one day, and no further reporting was necessary. To increase the pace of work the whole area could have been measured as a continuous long profile with a direct interpretation along the measurement.
