Detection of plastic pipes in a concrete floor

Description of problem

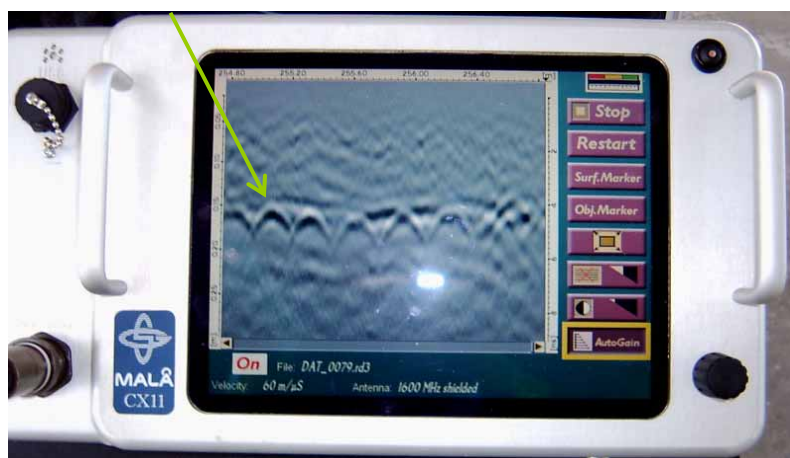
The CX together with the 1.6 GHz antenna gave good results (see picture below), the plastic pipes showed well (as clear hyperbolas, one marked with an arrow) on the radargram and the resolution was extremely good.

It was found that the majority of the pipe work system was buried at a depth exceeding 110 mm; only minor areas were found to rise to 100 mm. These areas were not of concern as they were relatively small and infrequent and did not coincide with the construction of the partitioned interior walls. However, two areas were found to have pipe work at less than 100 mm depth and in one case a reading as low as of 30 mm was found. These areas were clearly marked directly on the concrete surface.
