Investigation of the internal structure of a brick chimney

Description of problem

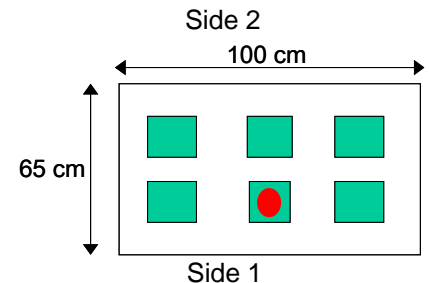
The chimney is constructed of bricks and contains six different pipes at the top of the chimney. Not all these pipes are however going from bottom to top of the chimney. Instead they start at different levels within the building. A simple sketch of the chimney top is given at right. The red mark shows the location of an aluminium pipe within one of the chimney pipes.

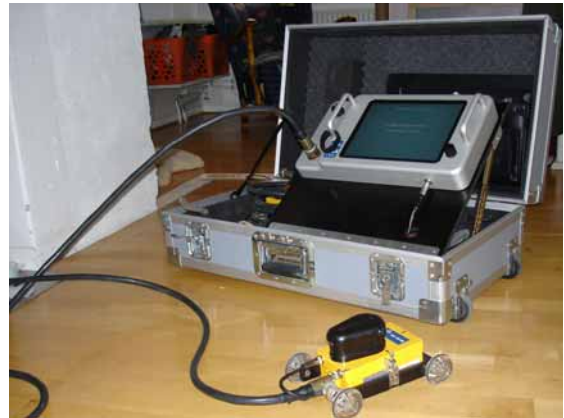
The measurements made in this application note were all carried out with Malå GeoScience CX system with the 1.6 GHz antenna.

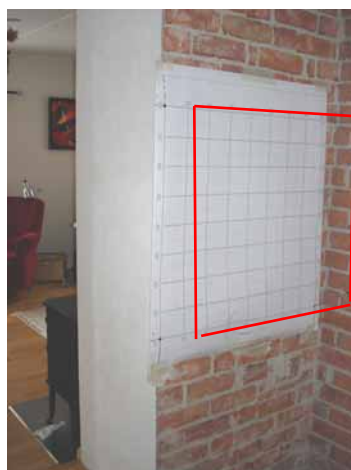
Side 1

The picture at left below is referred to as side 1, while the other side of the chimney (with the corresponding position of the measuring area marked with red) is referred to as side 2. As seen, a stove is installed at this side, which gives one indication of a pipe location. The red areas show the position of the made Grid measurements.

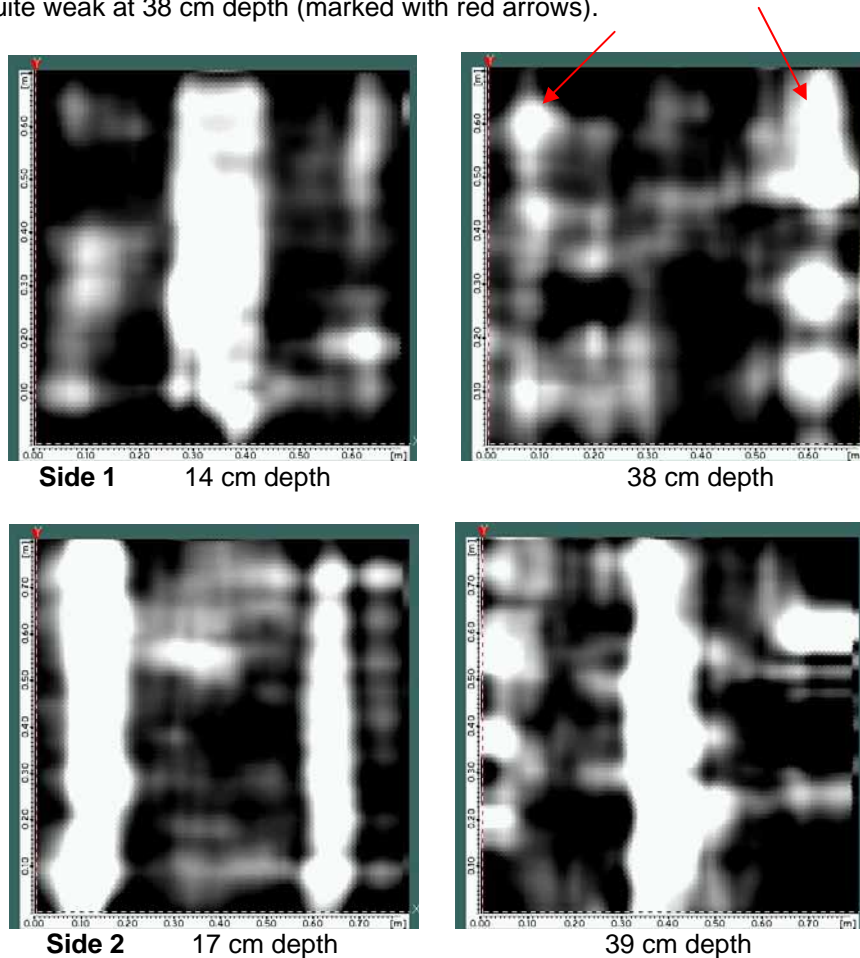
The two GridProjects made on the 1st floor clearly show the location of the chimney's internal pipes closest to the measured side. Indications of the second pipe layer is also seen from both sides. At side 1 the indications are quite weak at 38 cm depth (marked with red arrows).

At side 2 the reflections of the pipe closest to side 1 is as strong as measured from side 1 indicating a difference in material. This pipe, as seen above, contains the aluminium pipe with a diameter of approximately 5 cm.

From the two Grid measurements from side 1 and 2 on the 1st floor it can be concluded that the pipes are located as follows:

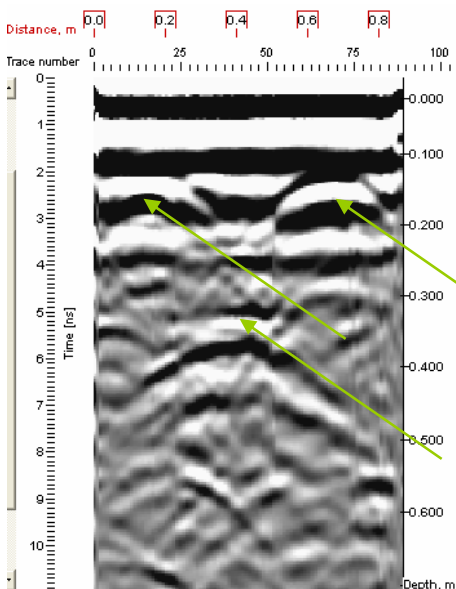
The radargram below is measured on side 2 from 0 to 80 cm (left to right). Also here the three identified pipes in the GridProject results above are seen very clearly, as quite wide hyperbolas, marked in the radargram with arrows.

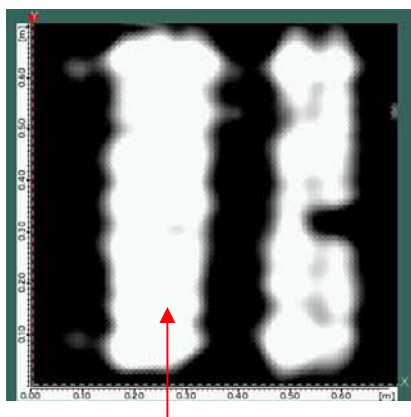
2nd floor 16 cm depth

On the 2nd floor only one side of the chimney was free to measure, this side corresponds to side 1 on the 1st floor.

Here two pipes were clearly identified at a depth of approximately 16 cm. One of these corresponds to the pipe from the first floor (the left one is on the same location as the pipe with the internal aluminum pipe, marked with an arrow) but also another is seen, a ventilation pipe starting between the two floors. Again the pipe containing the aluminum gives a bit stronger back-reflection. The two pipes are also seen in the single measured radargram as clear hyperbolas, marked with arrows in the picture above. However, the second layer is harder to identify, most probably due to the fact that the two pipe layers are situated on top of each other, giving reflections interacting. Unfortunately the GridProject could not be started at the edge of the chimney, so that's why the pipe from the stove is not seen at all.

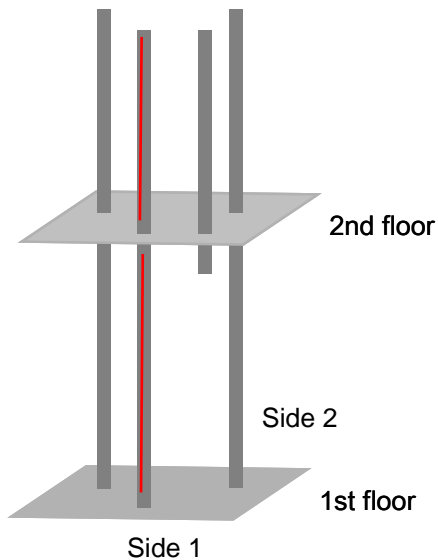
A simple drawing of the pipe location at 1st and 2nd floor is given at left. As seen the pipes on side 2 goes through both floors, while one of the pipe on side 1 only goes through the second floor. The chimney contains 6 pipes in total, so the two missing pipes in the picture at left are only going from top of the 2nd floor and up.

The pipe (on side 1) containing the aluminum pipe is marked with red.
